Survey of items

68 Lining

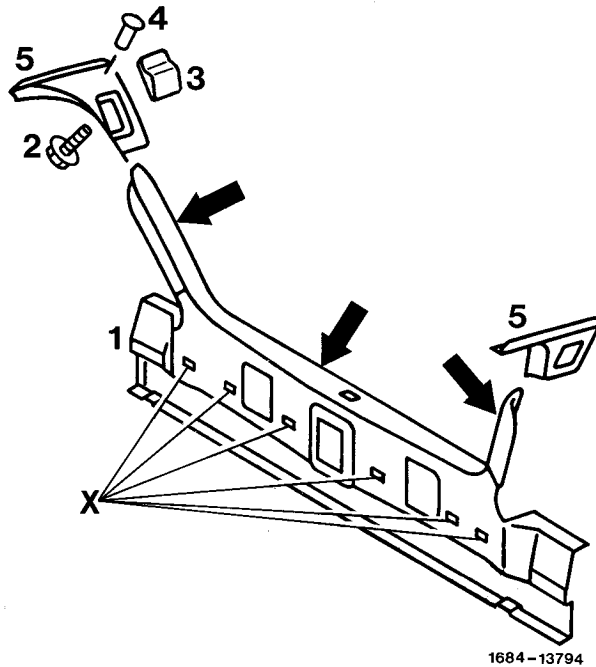
68-485 Removal and installation of trim on rear center piece

Note: Broken off plastic hooks (x) can be replaced with plastic dowels, part no. 001 997 39 86.

Trim (1)	clip out - in with plastic wedge (arrow) and screwdriver (x)
Trim (1) in forward direction	remove and install
Screw (2)	screw 2 each out - in
Stop (3)	remove and mount
Plastic rivet (4)	remove and install 2 each
Trim (5)	remove and mount

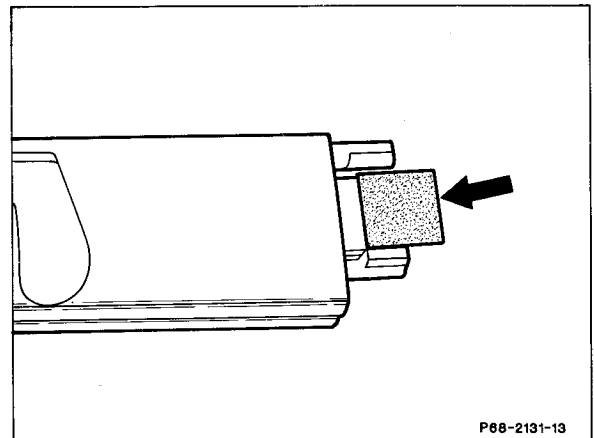
68-88021 Noises in belt height adjustment.

Too much clearance of slide in center pillar lining.

Glue felt to link of slide.

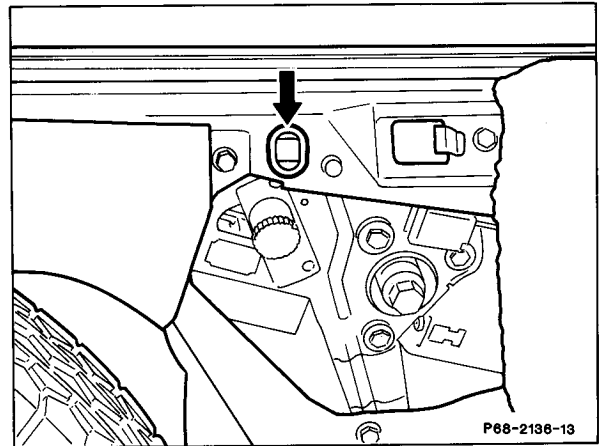
68-88051 Spare wheel lining (modified version) cannot be locked on vehicles manufactured prior to 10/86.

Oval opening in side wall for plastic bolt on lining missing (Fig.).

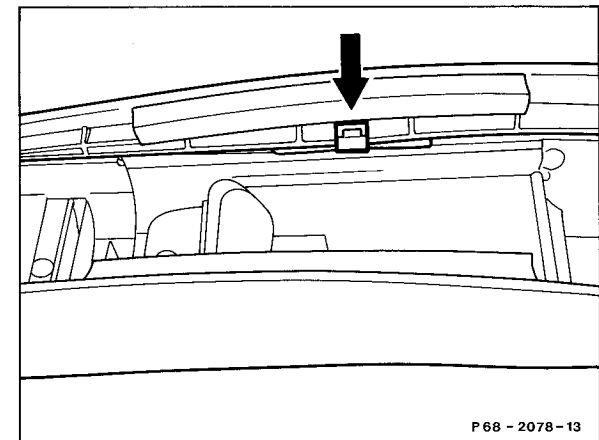
68-89121 Noises in belt height adjustment.

Too much play of slide in center pillar lining.

Install holding clamps (2 each), part no. 124 988 93 78, in center of slide guide.
