82 Body

Speed-related interference to radio reception and cassette operation, model 124.0

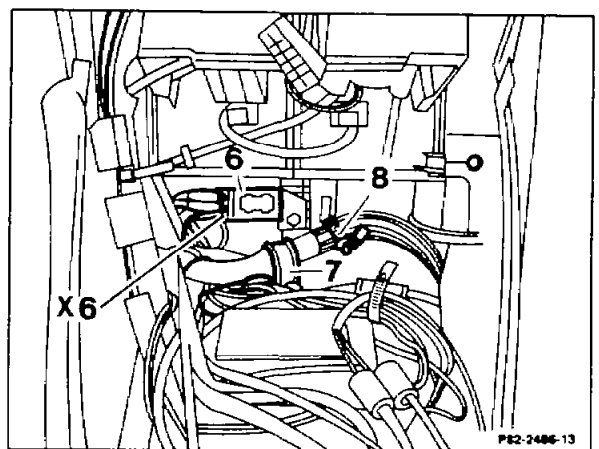
This interference (ignition interference) can be transmitted inductively by the wiring harness, which runs below the radio set.

Move terminal block, terminal 58d (X6) to the left. Install bracket (6) for this purpose. Re-attach wiring harness with clip (7) and cable strap (8).

Bracket part no. 124 545 20 40

Clip part no. 123 995 08 20
