Complaint:

Pedal pulsates during application of moderate braking force (not in active ABS regulation range) ABS malfunction indicator lamp not illuminated or illuminated sporadically during vehicle operation, until ignition is switched off.

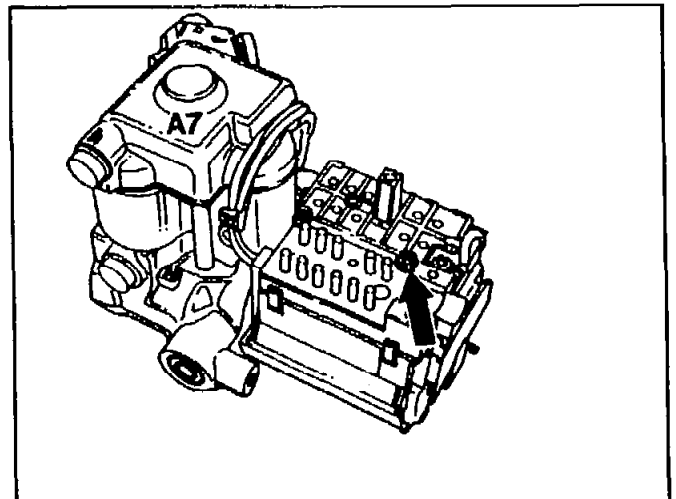
P42-2448-13

- a) Grounding point (W10) makes bad contact.
- b) Grounding point in plug socket on hydraulic unit makes bad contact.
- c) Valve relay defective or bad contacting.
- d) Diode in alternator defective.
- e) **On vehicles with diesel engine:**
Interference from preheating system cable harness to ABS cable harness.

- a) Retighten grounding point (W10).
- b) Unscrew fixing bolt for plug socket (arrow), place tooth lock washer underneath and screw in again.
- c) Check valve relay for contacting (plug socket) and function, rework contacting or replace relay if required.
- d) Check alternator for ripple, replace if required.
- e) Change cable routing, refer to the following working instructions.
