**Content Programmed repairs Front axle**

### 33 Front axle

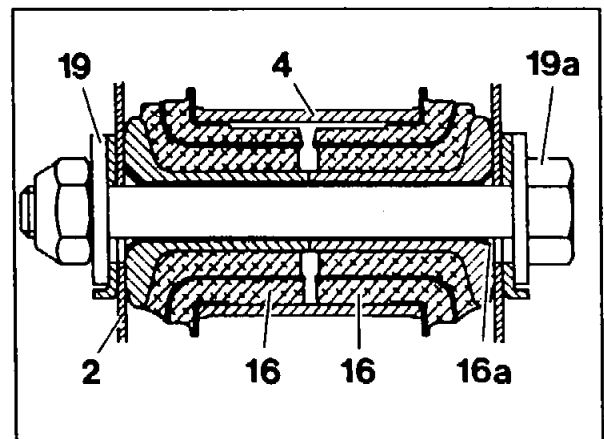
P33-5191-13

| 33-87067 | Entire vehicle shakes and torsional oscillations at steering wheel. | Model 124 up to 03/87 |

Since March 1987 (phased in) a modified control arm mounting has been installed on the front axle. The control arm has a two-piece mounting of high-damping torsion rubber elements at the front and rear. The distinguishing feature is the rear control arm mounting. This damps the vibration of the vehicle and torsional oscillations of the steering wheel..

#### Modified mounting (2-piece)

- 2 Frame cross member
- 4 Control arm
- 16 Torsion rubber mount
- 16a Clamping sleeve
- 19 Eccentric washer
- 19a Eccentric bolt

Vehicles with rubber mounts of the 1st version must be converted to the modified mounting in accordance with operation no. 33-0526.
