Programmed repairs Propeller shaft
Models 107, 114, 115, 116, 123, 124, 126, 129, 201

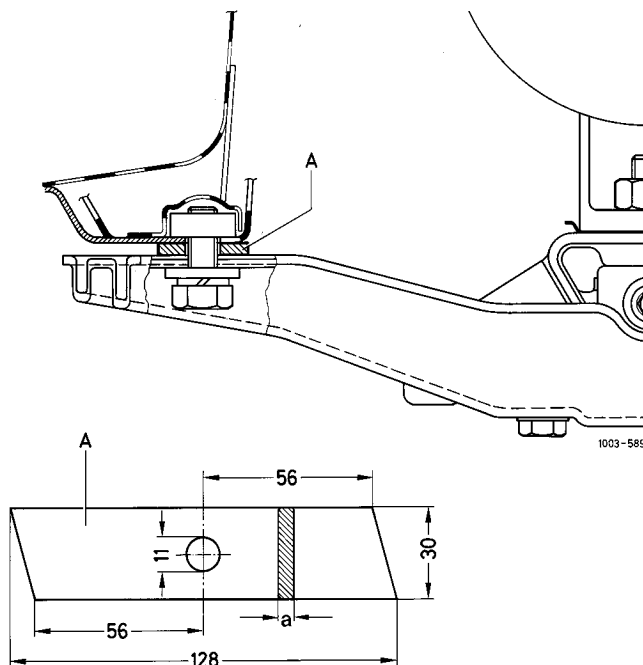
Figure 1

1. The articulation angle of the universal joint on the propeller shaft intermediate bearing is excessive in the speed range of 15 - 20 km/h.

A = Shim (shop-made)

Dimension "a" =
2-6 mm

Mount shims of a suitable height of 2-6 mm between the rear engine mount and frame floor.

Shims are to be shop-made (figure 1).

Hexagon bolts are to be extended corresponding to the shim thickness.

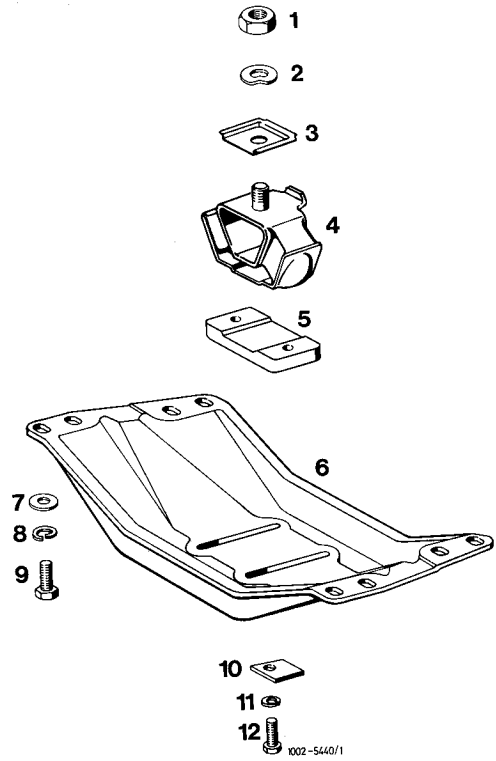
Figure 2

5 Aluminum shim

Replace 10 mm aluminum shims between the rear engine mount and rubber mount by a 6 mm or 4 mm aluminum washer (take bolt length into account appropriately).

On models 116.020/024/025 it may be necessary to remove any 4 mm aluminum shim (figure 2, item 5).

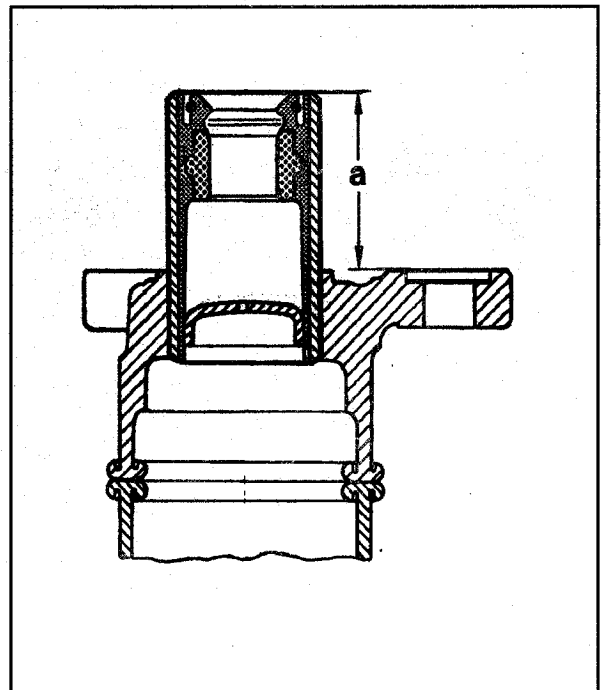
P41-5033-15

Rumbling/rattling in the no-load condition in the engine speed range between 3200-3800 rpm.

Model 201.018 with 4- or 5-speed manual transmission (up to 09/90, refer to technical modifications)

Install a soft pull-push flexible coupling in place of the torsionally rigid (hard) version, repair kit part no. 124 410 01 15. At the same time a new centering sleeve, part no. 124 410 07 32, must be installed. Installed dimension "a" is 30 mm (refer to figure, 41-200).

A new front propeller shaft, part no. 201 410 76 01, must be installed on vehicles with 5-speed manual transmission.

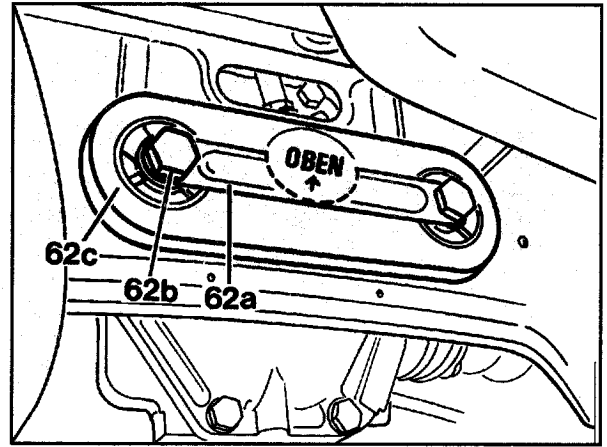
P41-2045-13

Booming (rumbling) in the speed range from 110 km/h to 150 km/h.

Vibrations in drive line due to unfavourable, coincident production tolerances.

3. Screw vibration damper, part no. 124 350 03 72 (1st version) onto the rear mounting of the rear axle center piece assembly (refer to figure). Tightening torque 150 ± 10 Nm.

On all T-saloons **with auxiliary heater, no damper** may be assembled on the rear axle. On all T-saloons, only the 2nd version of the damper may be installed in conjunction with the adapter holder (for part no., refer to parts microfiche).
