Survey of items

68 Lining

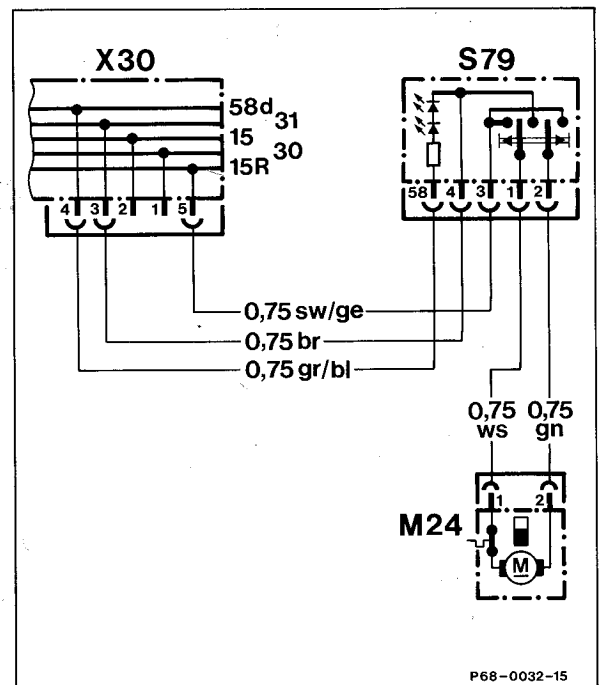
Wiring diagram electric scissors-type roller blind for rear window (without head restraints, as of approx. 01/90)

If on vehicles with head restraints the roller blind is not completely attaining the retracted position, the head restraints cannot be lowered, since the head restraints lowering device is connected to the roller blind by means of a microswitch.
